# Examples of Asbestos Projects Requiring Funding

# Examples of Lead Abatement Projects Requiring Funding

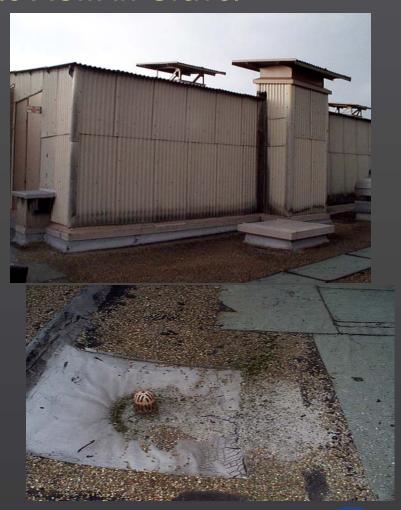
#### Building 23 – Friable ACM in Gravel

- Matrix of the transite decomposed releasing asbestos fibers
- Rain washes asbestos down to roof drains
- Friable asbestos is present throughout gravel.
- \$85K for ACM removal throughout the gravel and gravel replacement.

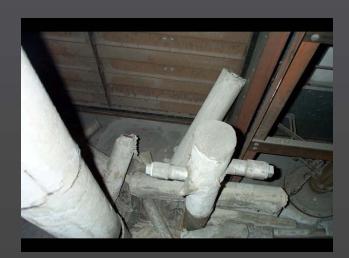
#### Bldg 23 – Abandoned Piping with friable TSI

- Remove abandoned
   piping in all 4 penthouses
   that have asbestos
   containing insulation.
- One penthouse provides make-up air to building and the insulation is significantly damaged.
- \$40,000

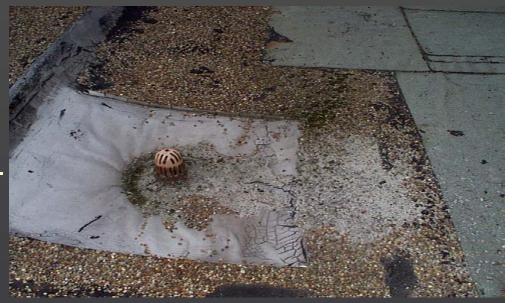
## Building 23 – Friable ACM in Gravel

- Matrix of the transite decomposed releasing asbestos fibers
- Rain washes asbestos down to roof drains
- Friable asbestos is present throughout gravel.
- \$85K for ACM removal throughout the gravel and gravel replacement.

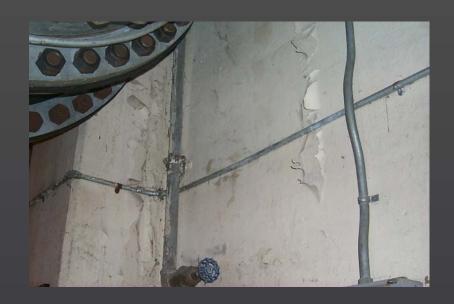
## Building 37 - Perimeter Walls

- The lead containing paint on perimeter walls is deteriorated and flaking on floor.
- Hand scrape loose paint and repaint
- \$30K

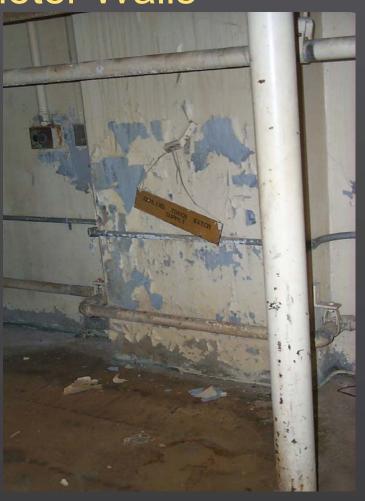
### **Building 5 Perimeter Walls**

- Perimeter Walls with lead containing paint are deteriorated and flaking on floor
- Hand scrape loose paint and repaint
- \$60K
